***ABBREVIATED PRELIMINARY ASSESSMENT***

***AKERS MINE***

Malheur National Forest  
Grant County, Oregon

November 2002

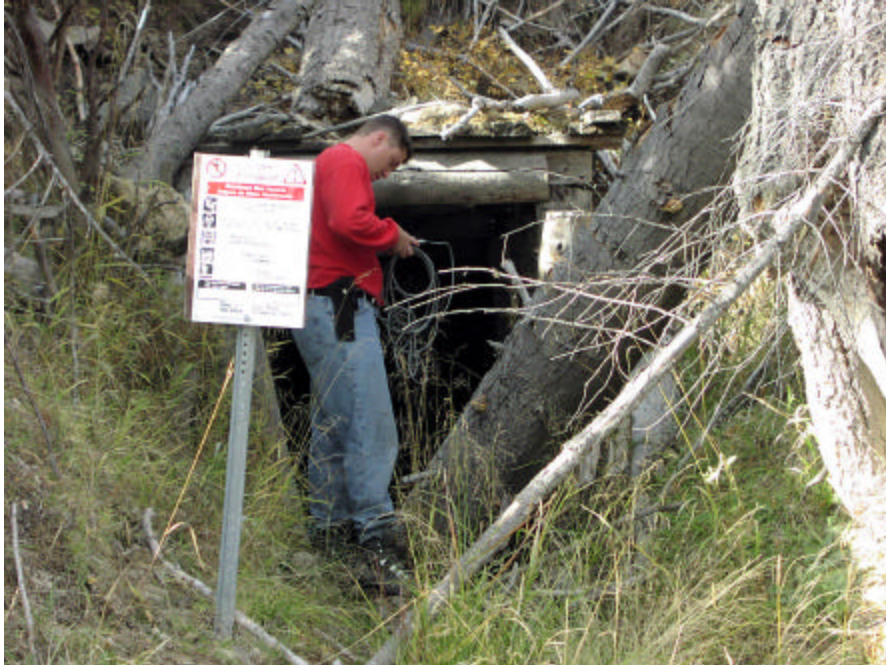
The Site consists of an adit, two small pits, and a large waste rock pile. The adit is located approximately 40 feet west of Windlass Creek. The portal to the adit is open and the adit opens to the east toward Windlass Creek (Photograph 1). Water was observed on the floor of the adit and flowing out of the adit into Windlass Creek. One of the pits is located north of the adit on the west side of Windlass Creek. The other is located on the east side. A small gangue pile was associated with the pit north of the adit. The waste rock pile is located adjacent to and trends south along Windlass Creek for approximately 130 feet. Windlass Creek crosses in front of the waste pile through a wooden culvert. Trees and bushes were observed growing on the waste rock pile (Photograph 2). There are no structures at the Site or in the area. Approximately 0.25 acres are disturbed on the Site according to the USFS survey. During the site visit, a rotten egg odor was detected while analyzing the waste rock pile; this likely indicates the presents of sulfurous compounds in the waste rock.

One water quality assessment was collected using a Horiba U-22 from the seep emanating from open adit (Photograph 1). Water quality parameters assessed were pH, specific conductance, turbidity, dissolved oxygen (DO), temperature, total dissolved solids (TDS), and oxygen reduction potential (ORP). Results of the adit seep water quality assessment are presented below.

**Photograph 1: Akers Mine. Collecting adit seep water parameters from water in the open adit (Photograph by John Martin, CES, October 21, 2002, 13:44).**

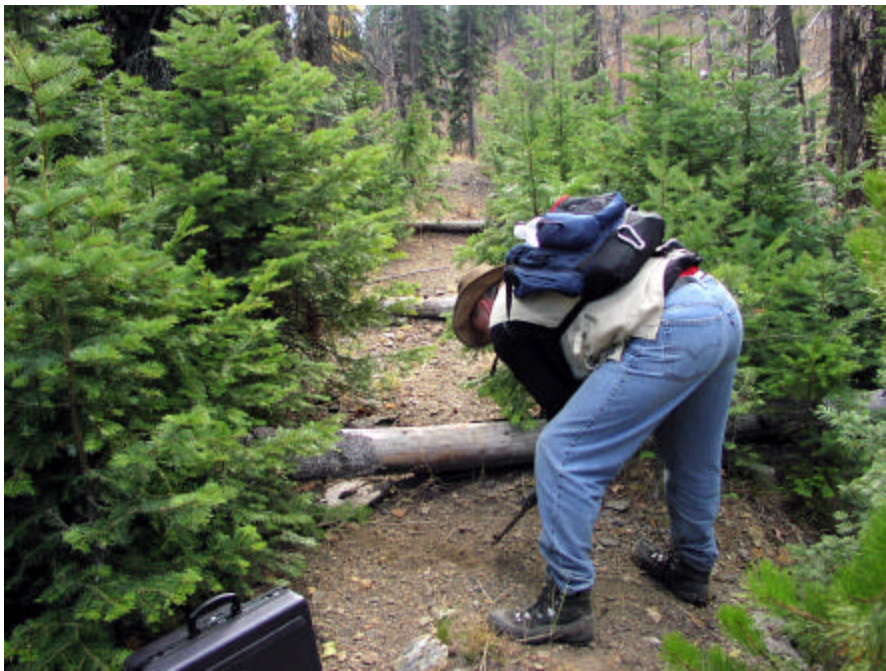
**Photograph 2: Akers Mine. Waste pile , southeast of open adit (Photograph by John Martin, CES, October 21, 2002, 14:12).**

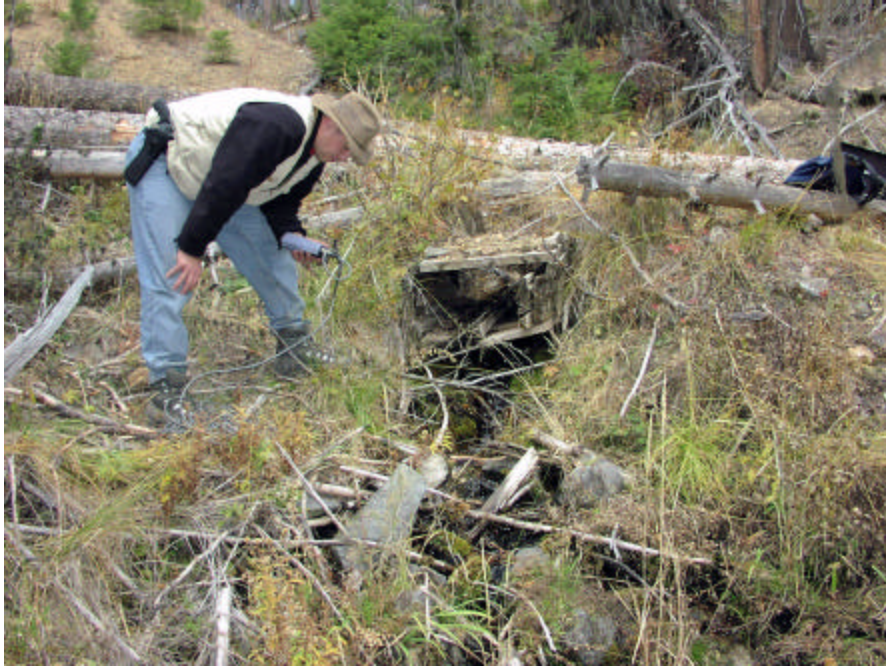
A portion of the Akers Mine waste rock pile lies within the flood plain of Windlass Creek. In addition, Windlass Creek flows through the lower portion of the waste rock pile via a partially buried wooden culvert. It was apparent erosion forces are contributing some material to Windlass Creek. The Site is not near any residential areas or drinking water wells.

**Photograph 3: Akers Mine. Collecting water parameters from Windlass Creek below the waste rock pile. Note the wooden culvert in which the creek flows through. (Photograph by John Martin, CES, October 21, 2002)**

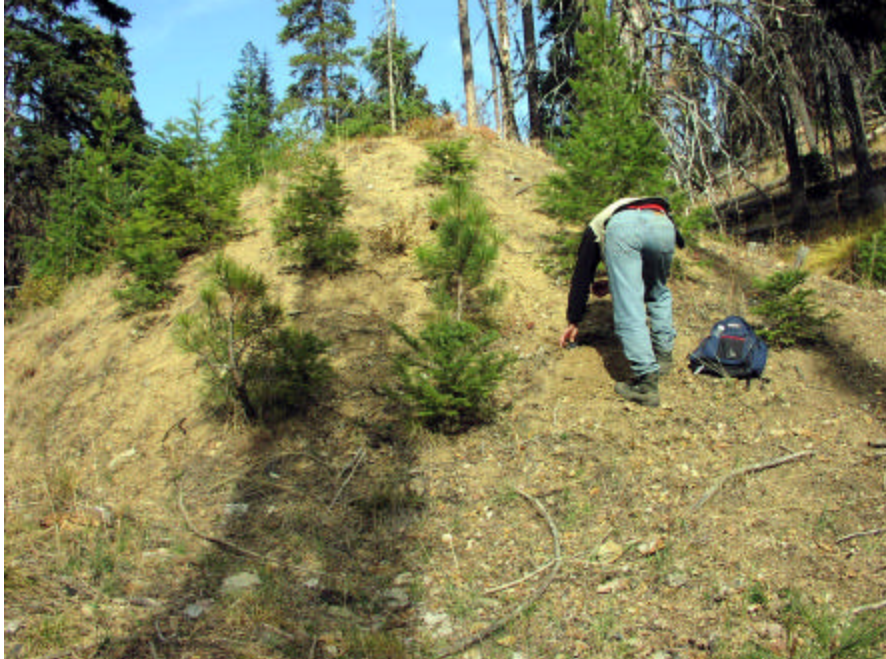
**Photograph 4: Akers Mine. Face of waste rock pile located in the floodplain of Windlass Creek (Photograph by John Martin, CES, October 21, 2002).**

Based on the *in situ* screening of the waste rock pile with the Niton XRF unit and the proximity of the waste piles to Windlass Creek, additional investigation is warranted. As part of this investigation, surface water and pore space water samples should be collected. In addition to analyzing the water samples for the EPA target analyte list (TAL) for total metals, field parameter readings pH, conductivity, turbidity, dissolved oxygen, temperature, total dissolved solids, and oxygen reduction potential should be collected.

Benthic and sediment samples should be collected from Windlass Creek and analyzed for the total metals. The waste rock piles should be sampled with depth in order to determine the lateral and vertical extent of impacted material. Background soil samples should also be collected from undisturbed areas. All soil and waste rock samples should be analyzed for the TAL for total metals, acid-base accounting (ABA), and pH. In addition, a wildlife, plant and fisheries survey should be conducted to determine what effects, if any, the Site has had on ecological receptors.
